VSR REPORT

MAG – IAS Hebron, KY Stress Relief Stabilization of 2 meter and 3 meter plates

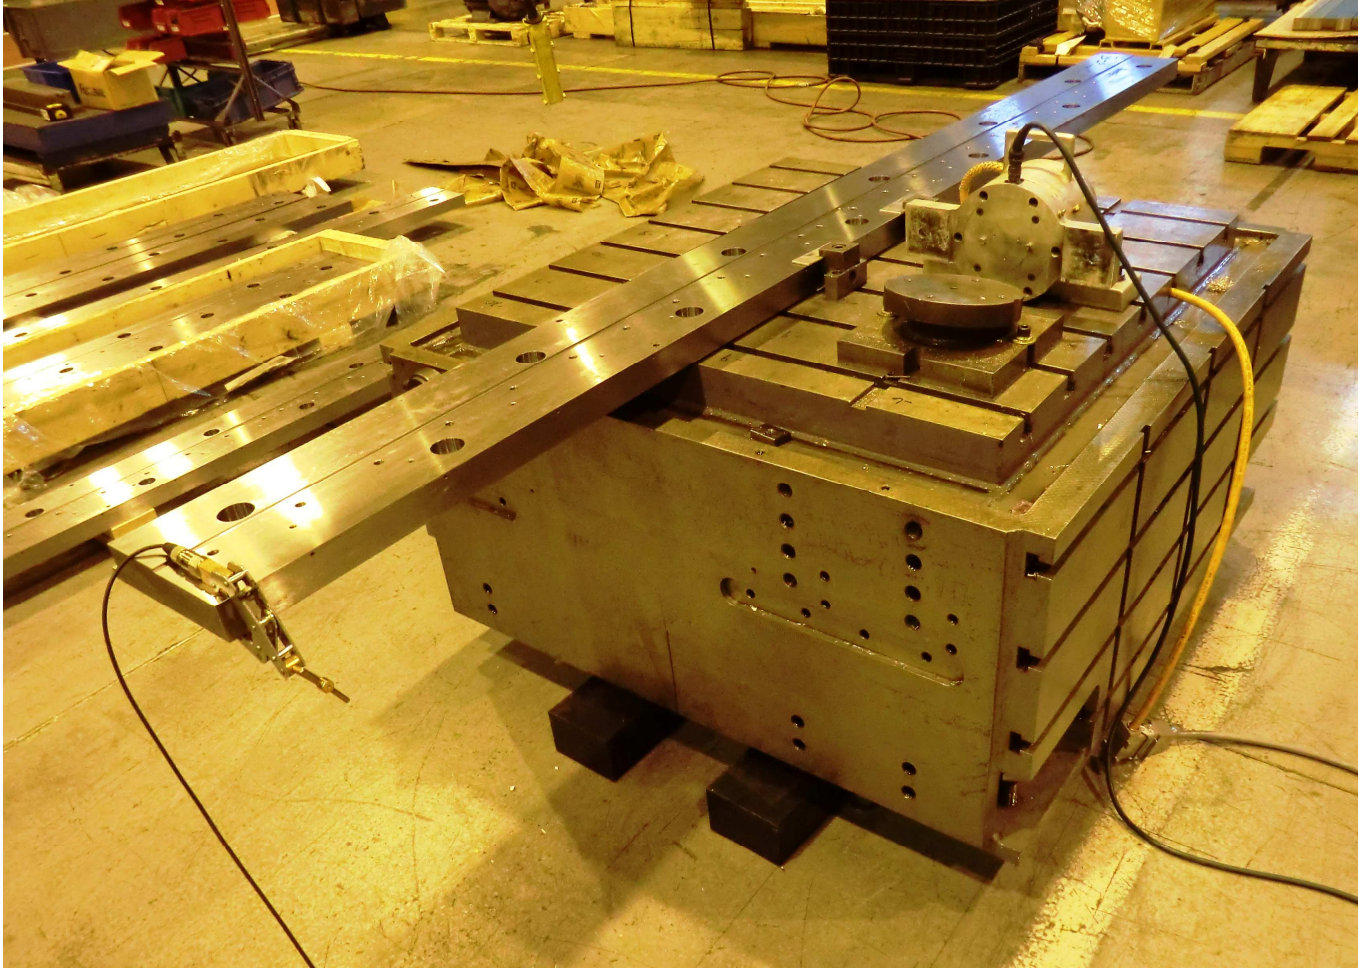
Figure 1: 3 meter long plate setup for VSR Treatment. A T-slotted fixture was mounted on four urethane load cushions, two of which are visible in the middle-foreground. The workpiece was shimmed above the T-slotted fixture using 1/8" CRS, ~ 2" X 3", at 3 locales coinciding with the clamping points: One near the center of the leftward side, the other two separated by two T slots. The fixture, shims and clamps thus acted as a medium thru which the vibration was transmitted. This arrangement minimized the damping of the workpiece, allowing the resonances of the workpiece to be available for the VSR Process. The 2.3 kW vibrator (which has both variable unbalance and speed) was bolted to the fixture, with its AOR (Axis of Rotation) parallel with the workpiece length, since lengthwise resonance was unlikely. Tooling in front of the vibrator was present on the fixture when provided, and was left in place, and made no contribution to the vibration data.

When MAG – IAS, LLC had a collection of 8 thick steel plates that proved dimensionally unstable, they turned to Advanced VSR to use the VSR Process in an effort to stabilize them. These plates had been thermally stress relieved and then machined. Changes in shape that took place during transport rendered them useless, using the intended design, so a modified design was developed, and the plates VSR Processed, with the hope of avoiding having the scrap the material. Dimensional tolerances over the 2 and 3 meter long (~ 80" and 120") lengths were in the range of +/- 0.001". The VSR Setup used to stabilize the plates is shown in Figure 1.

Each workpiece was clamped upon a T-slotted fixture, resting upon three shims, ~ 1/8" X 2" X 3", with the clamping centered on each shim. Three is the minimum number to determine a plane, and the location of the shims / clamps was far from the ends of the workpiece, thus minimizing damping of the workpiece. Minimizing damping maximizes the modes and intensity of resonance, and hence, flexure. Independent research has shown that flexure is a key criteria required to maximize the effectiveness of vibratory stress relief.¹²

The Vibrator was securely bolted at the mid-length of the top of the fixture, and oriented so that the Axis-of-Rotation (AOR) was aligned with the length of the workpiece. The resonances most likely to be excited would cause vertical deflection of the workpiece, with some possibility (achieved with the 3 m long plates) of "sideways" resonating. As is often the case, the probability of exciting a resonance generating length-wise amplitude was minimal, so the vibrator was aligned purposely so as to drive the workpiece in the most likely directions of resonating.

An Accelerometer (a vibration sensor whose output is proportional to acceleration) was positioned on one corner of the workpiece, and oriented to be most sensitive to vertical amplitude during the smaller plate stress relief treatments. For the longer plates, the accelerometer was oriented to be sensitive to horizontal deflections, as shown in Fig 1.

Setup used for the 3 meter long plates was similar in clamping to fixture, but different in both vibrator unbalance and accelerometer orientation. Two peaks were discovered at very different RPM ranges: A high-frequency peak at ~ 6000 RPM, and low-frequency peaks in the range of 1200 – 1500 RPM. Furthermore, these resonances caused deflection in different directions: The 6 KRPM peak caused amplitude chiefly horizontally (side-to-side), while the low-frequency peaks were chiefly vertical. It was during one of the high-frequency peak treatments that the photo shown in Fig. 1 was taken.

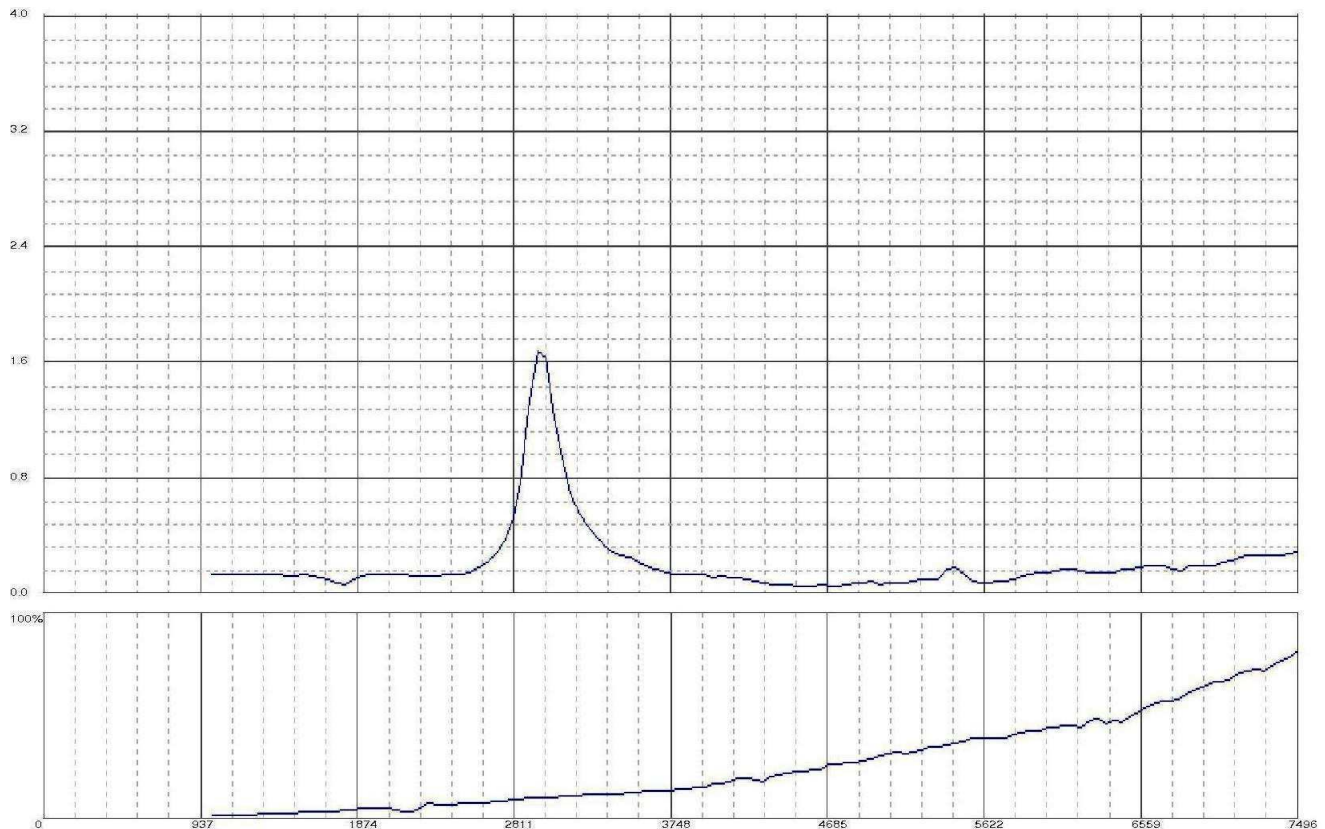
Figure 2: Workpiece 1, Quick Scan. VSR charts have two sets of data: An upper workpiece acceleration curve, calibrated in g's and a lower vibrator input power curve (with fixed full-scale [FS], with 100% = 2.2 kW), both these data sets plotted vertically vs. a horizontal axis = the vibrator speed, calibrated in RPM. Peaks in the upper curve are resonances of the workpiece, while peaks in the lower curve (which did not occur during this project) represent a resonance that causes increased, perhaps excessive, vibrator amplitude.

RPM FS = 7500 RPM
 ACC FS = 4 g's
 UNBALANCE = 1.0 in-lbs.
 POWER FS = 2.2 kW (fixed)
 SCAN RATE = 50 RPM / SEC\

A Quick Scan (all of which are recorded in blue “ink”) is used to allow calibration, documenting that at least one resonance is achieved, rescaling the acceleration scale if required (adjustable FS from 1 – 50 g's), and verifying that nothing is loose or loosening. Quick Scans are made at a rate of 50 RPM / sec, which is 5 times faster than what is normally used for Pre- or Post-Treatment Scans, the trade-off being time vs. resolution. Quick Scans can “lop-off” or miss the full height or other detail of a resonance, so they are used for calibration only.

After the initial setup, a Quick Scan (Figure 2) was performed, which showed only one significant resonance peak at ~ 2800 RPM. A Pre-Treatment Scan, which is performed using a scan rate 5 times slower revealed no additional significant additional peaks, even thou the scan went out to 7500 RPM (system max = 8 KRPM).

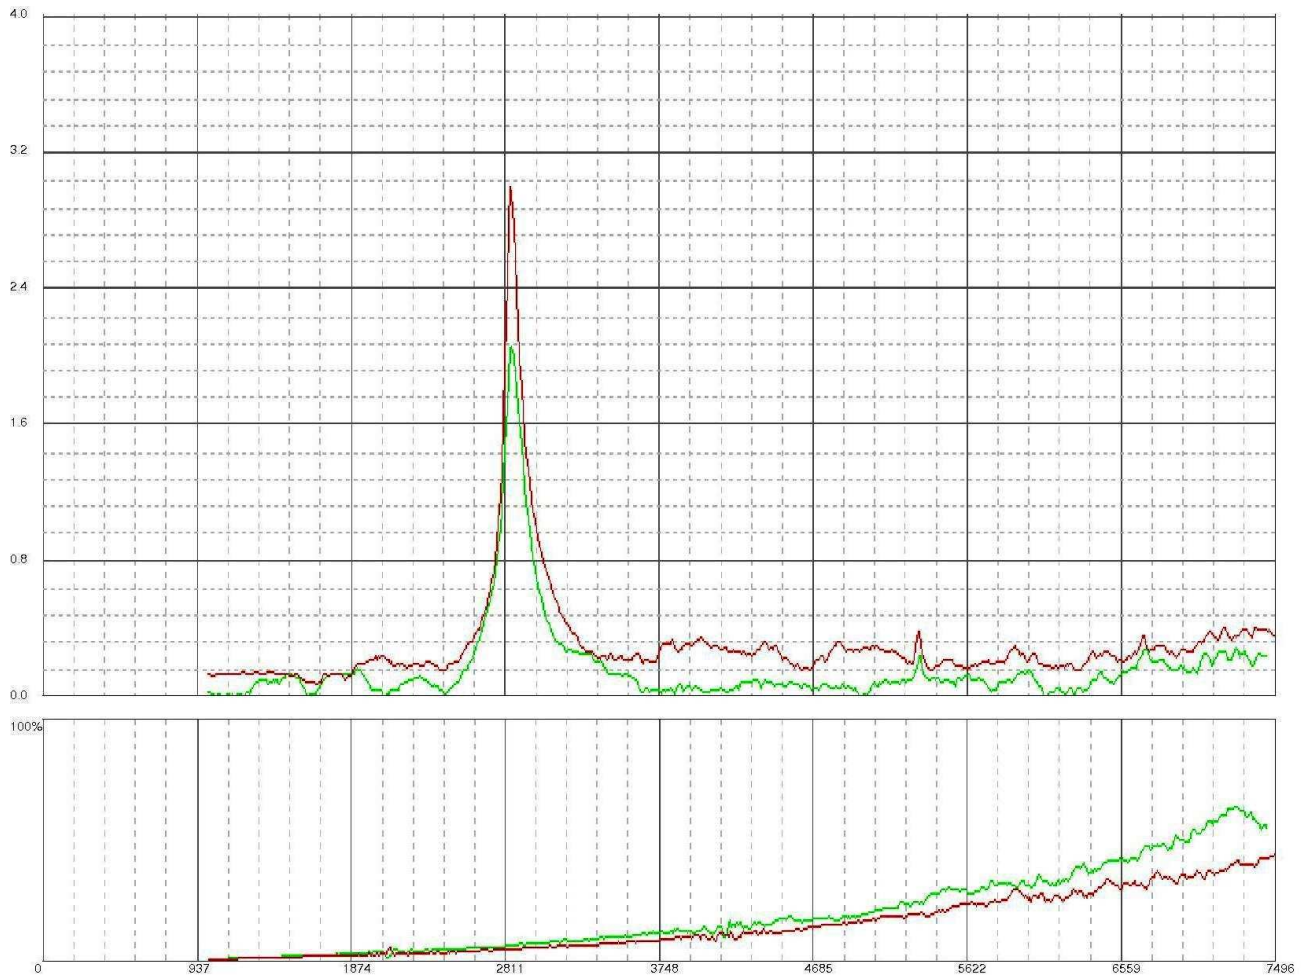
Figure 3: Workpiece 1, 1st VSR Treatment. After the QS was made, a Pre-Treatment Scan (Pre-Scan) was made and recorded in green. With only the green Pre-Scan, the operator then chooses which peak(s) to tune upon and dwell. The real-time amplitude is displayed by a cursor (not shown) and the digital displays on the VSR OS. These are used to monitor the progress of the VSR Treatment. Dwelling upon a peak takes place until stability is reached, whatever form the changes might be. Chiefly, peak changes are peak growth. Peak shifting (most often to the left), but also peak shrinkage and shifting to the right can occur. When able to be verified, these latter changes normally indicate a change in workpiece shape / dimensions.

RPM FS = 7500 RPM
 ACC FS = 4 g's
 UNBALANCE = 1.0 in-lbs.
 POWER FS = 2.2 kW (fixed)
 SCAN RATE = 10 RPM / SEC

After the changes in the resonance at ~ 2800 RPM (which chiefly involved peak growth of ~ 46%) stabilized, a Post-Treatment Scan or Post-Scan was made, recorded in red, superimposed on the baseline / Pre-Scan.

After tuning on the 2800-RPM peak, peak growth was noted within two minutes. The remaining increase, amounting to growth of $\sim 46\%$, took an additional 25 minutes to achieve, at which point the peak height remained stable. A Post-Treatment Scan (which is recorded in red) was performed, documenting the changes that had taken place during treatment.

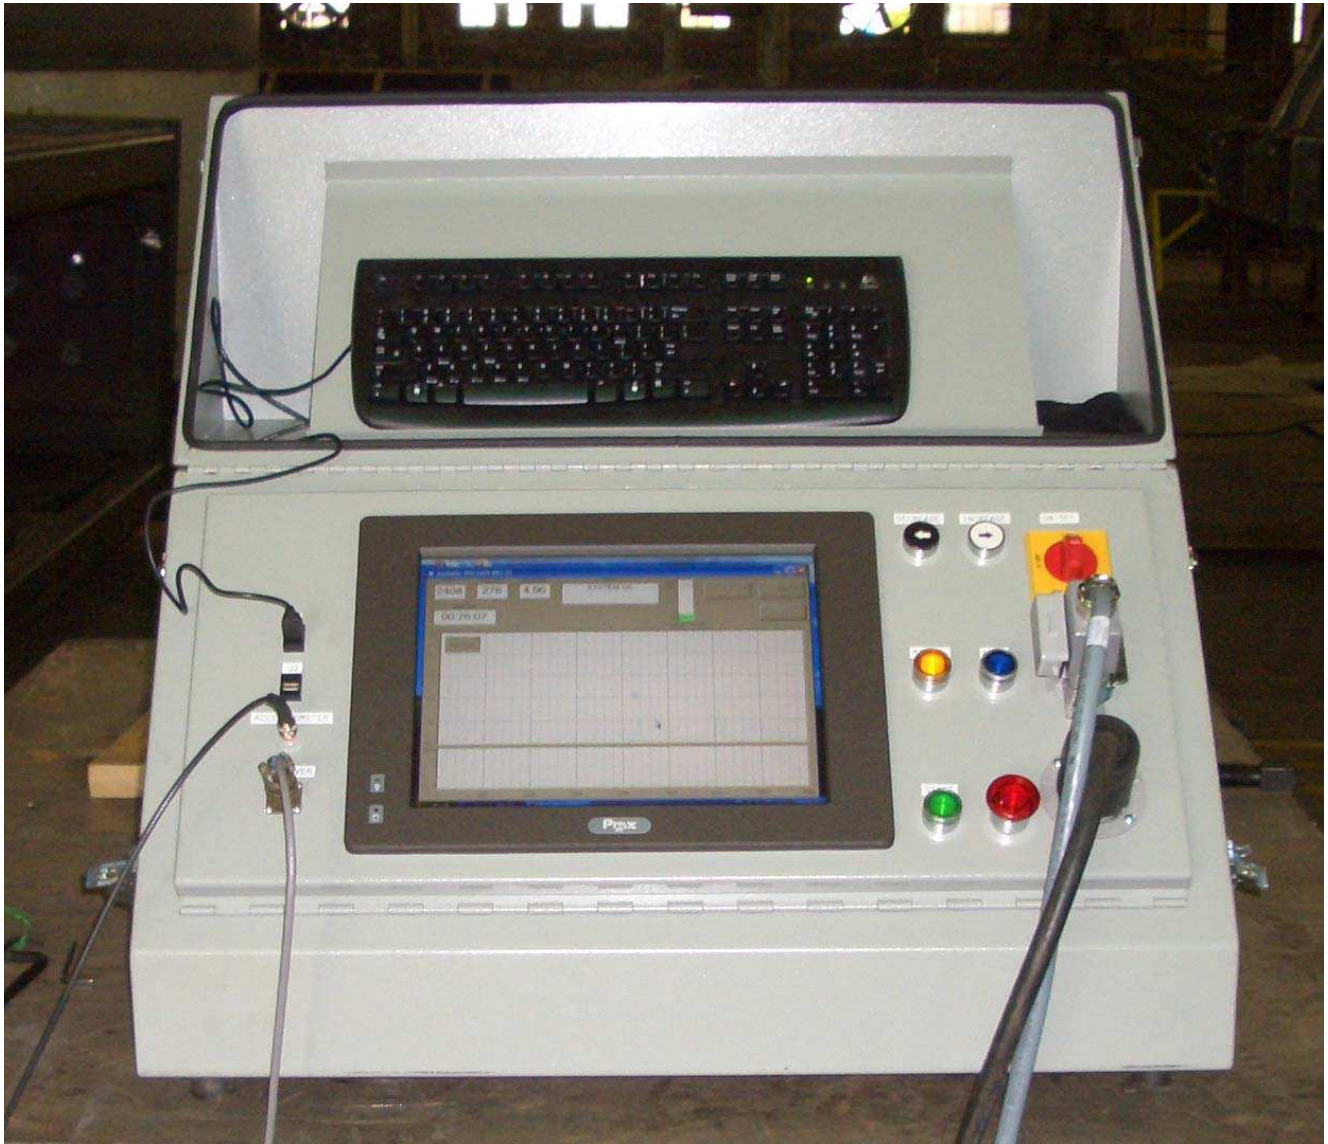
Figure 4: MX-8000 VSR Console. Touch-screen computer displays VSR Chart Data, digital data (RPM, power, and acceleration). Chart data is saved by printing in Adobe/pdf format. Low voltage connections are on left (2 USB Ports, Accelerometer, and Vibrator resolver / tachometer), and higher voltage connections on right (power in, motor). With vibrator speed regulation of $\sim 0.02\%$ and acceleration display error less than 0.5% of full-scale, the console's instrumentation provides more than adequate (on the order of one order of magnitude) accuracy to depict than changes seen during these VSR Treatments.

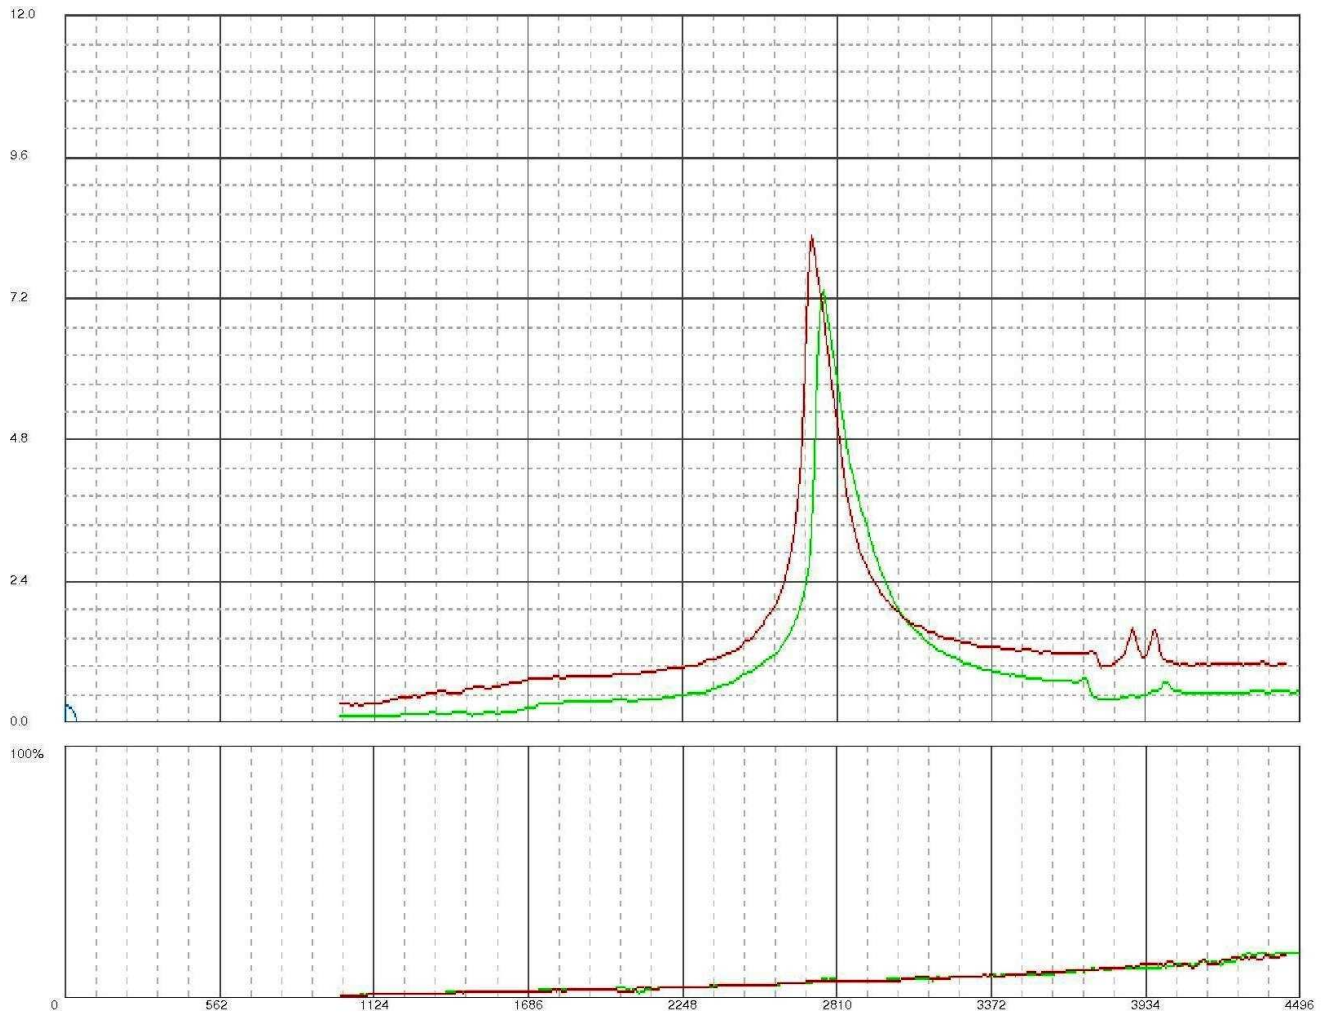
Figure 5: 2nd VSR Treatment Chart. To verify that the 1st treatment was sufficient, not only in treatment time but intensity, a 2nd treatment was performed at ~ 3X higher unbalance: 80% or 3.2 in-lbs. Some additional change took place (~ 13 % growth and ~ 1%, or 30 RPM peak shifting to the left), over a period of 15 minutes. 5 additional minutes yielded no further change, at which point a Post-Scan was performed.

RPM FS = 4500 RPM
 ACC FS = 12 g's
 UNBALANCE = 3.2 in-lbs.
 POWER FS = 2.2 kW (fixed)
 SCAN RATE = 10 RPM / SEC

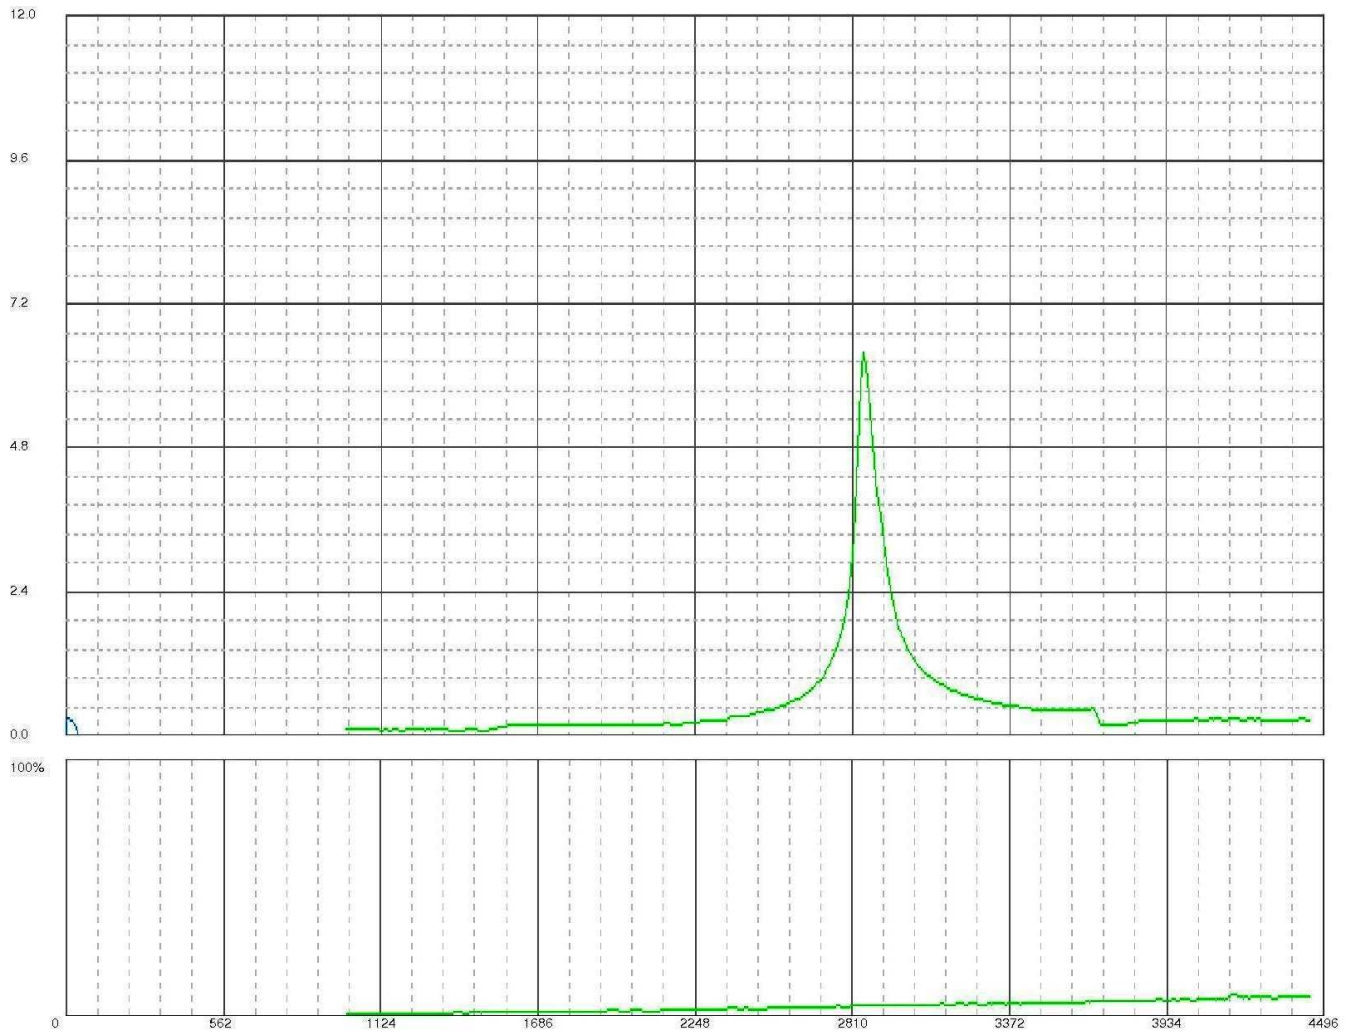
Figure 6: Workpiece 2 Pre-Scan. Using the same setup as used to generate Figure 5's data, the Pre-Scan shows a similar resonance peak slightly above 2800 RPM. This is the baseline data the VSR Operator sees at the beginning of a treatment, from which is gauged treatment progress.

RPM FS = 4500 RPM
ACC FS = 12 g's
UNBALANCE = 3.2 in-lbs.
POWER FS = 2.2 kW (fixed)
SCAN RATE = 10 RPM / SEC

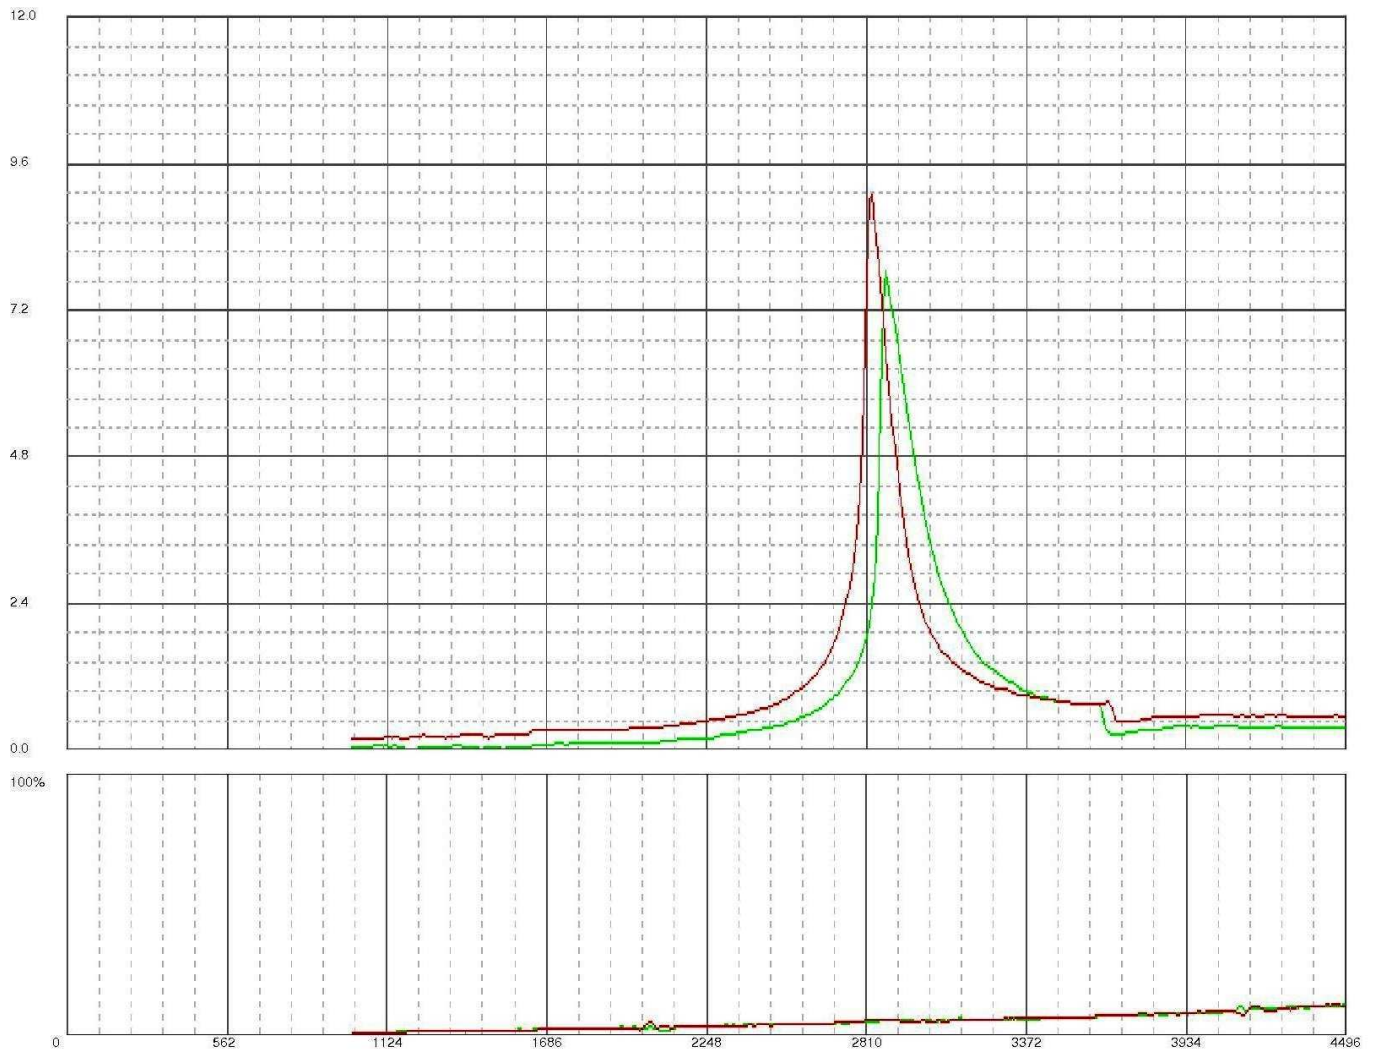
Figure 7: Workpiece 2 treatment shows peak growth from 7.7 to 9.1 g's, or ~ 18%, and peak shift leftwards from 2890 to 2820 RPM, or ~ 2.5%.

RPM FS = 4500 RPM
ACC FS = 12 g's
UNBALANCE = 3.2 in-lbs.
POWER FS = 2.2 kW (fixed)
SCAN RATE = 10 RPM / SEC

Based upon this response, the remaining 2 meter long plates were treated using first the 80% unbalance setting (results shown in Fig. 7), followed by the 25% (Fig. 8).

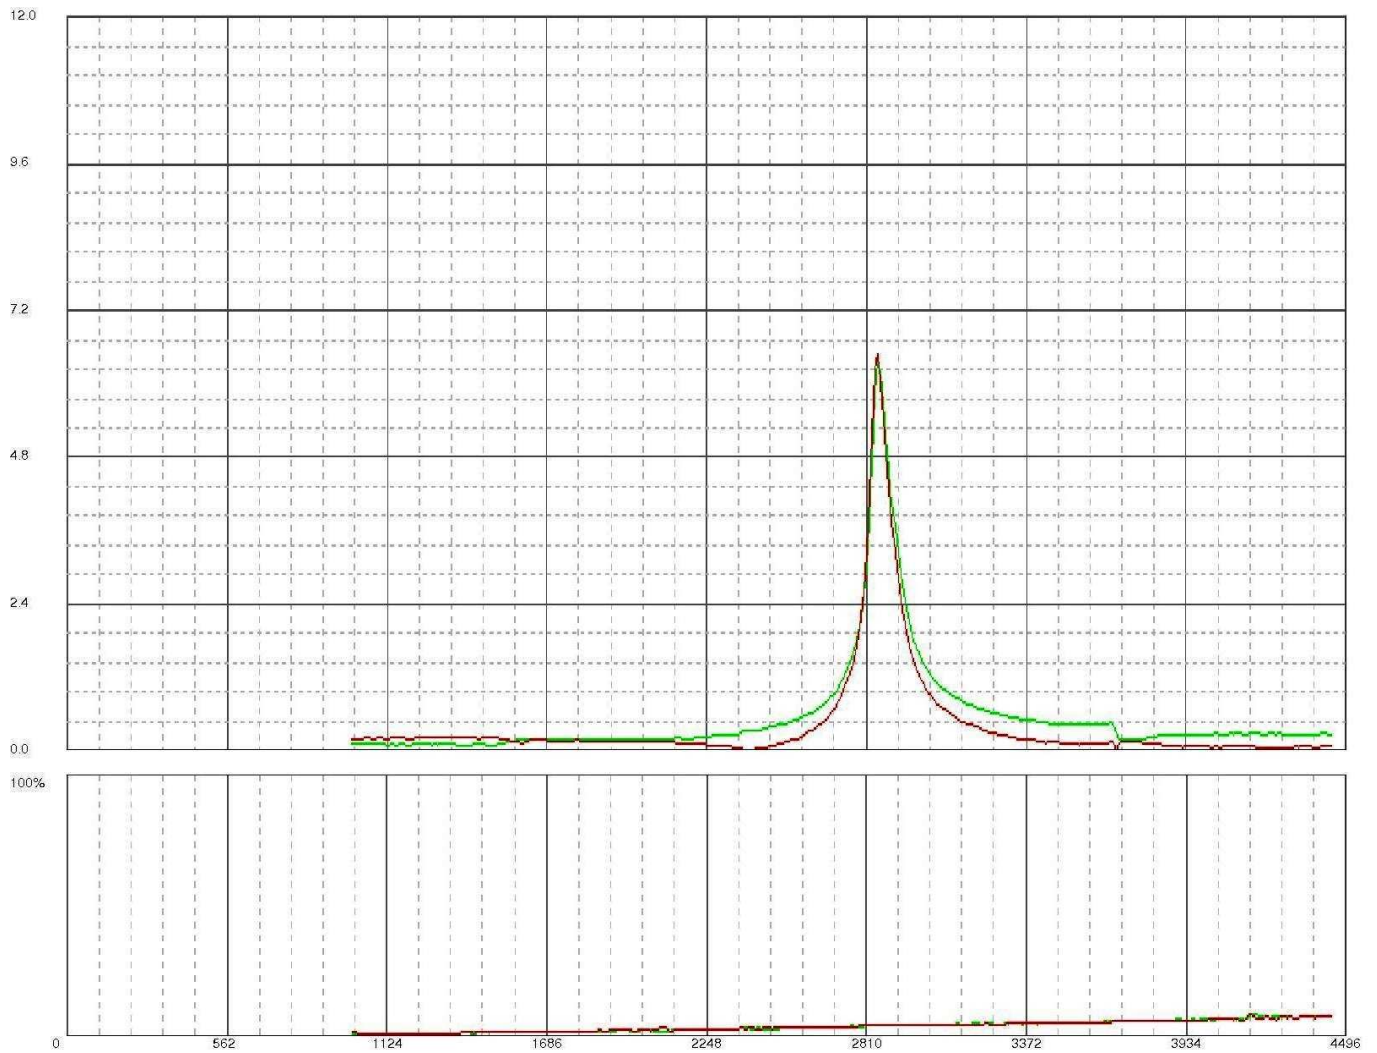
Figure 8: 2nd treatment of workpiece 2 at 25% unbalance yielded very little change, indicating the viability of using the 80% unbalance setting (shown in Fig. 7).

RPM FS = 4500 RPM
ACC FS = 12 g's
UNBALANCE = 1.0 in-lbs.
POWER FS = 2.2 kW (fixed)
SCAN RATE = 10 RPM / SEC

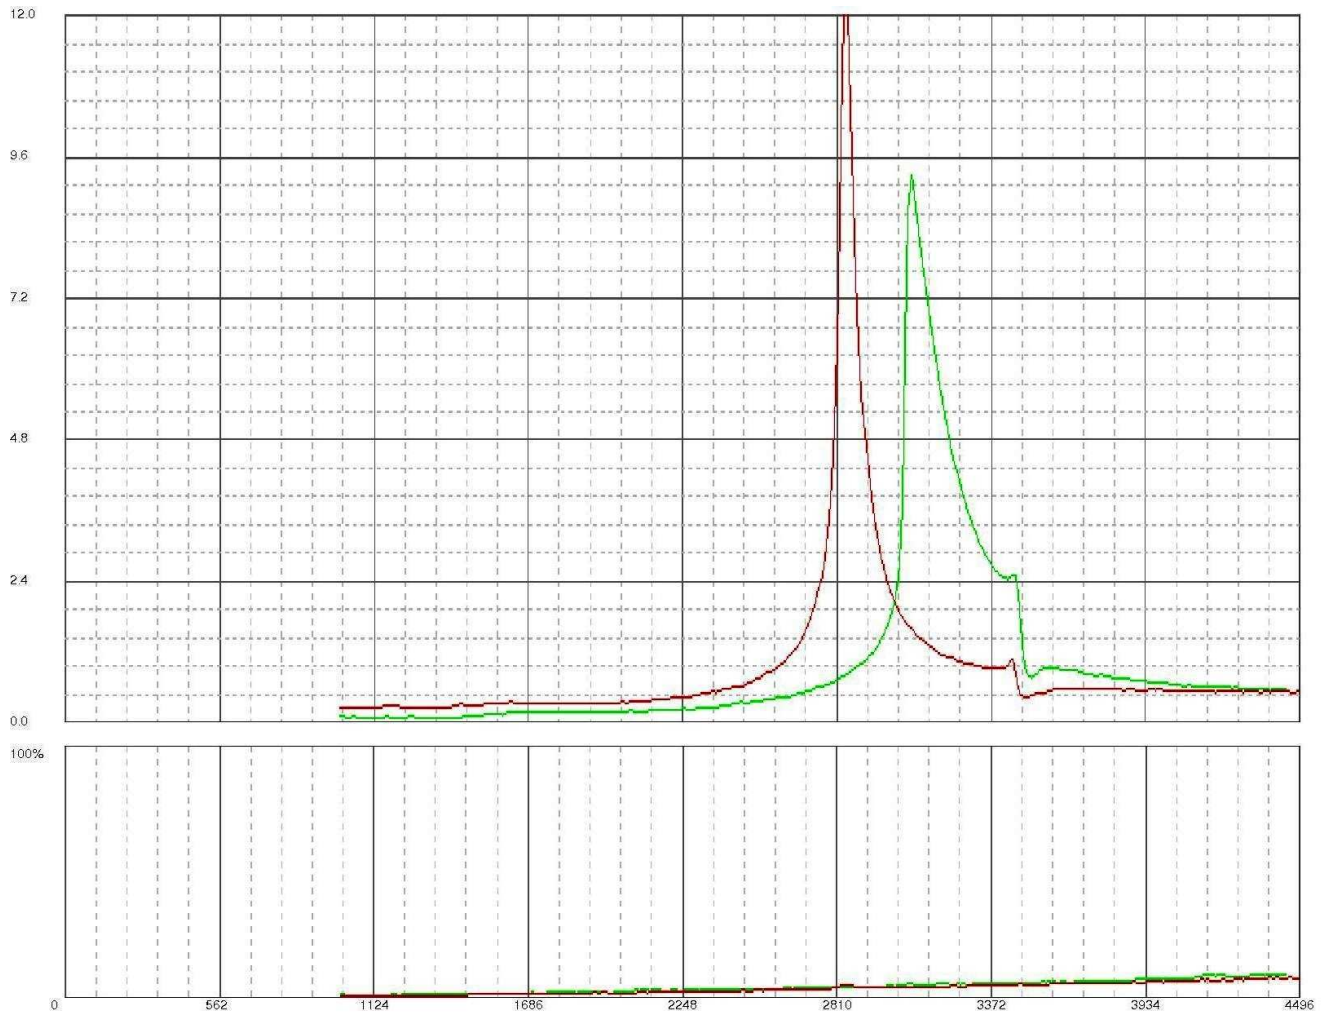
Figure 9: Workpiece 3 treatment using 80% unbalance yielded similar peak growth, but larger peak shifting.

RPM FS = 4500 RPM
ACC FS = 12 g's
UNBALANCE = 3.2 in-lbs.
POWER FS = 2.2 kW (fixed)
SCAN RATE = 10 RPM / SEC

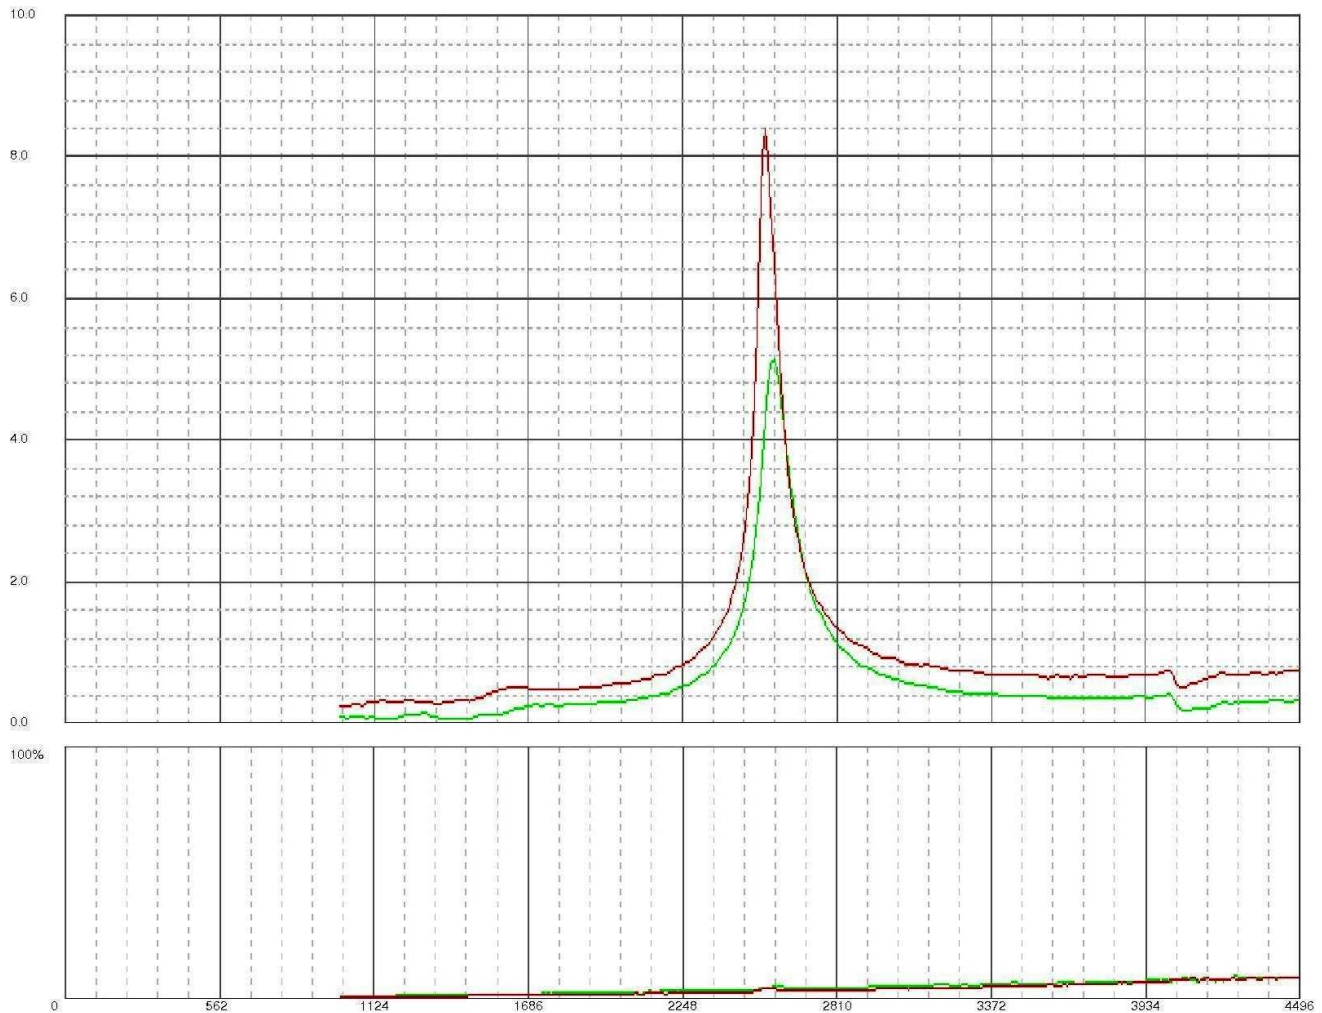
Figure 10: Workpiece 4 treatment using 80% unbalance yielded similar peak growth, but nominal peak shifting.

RPM FS = 4500 RPM
ACC FS = 10 g's
UNBALANCE = 3.2 in-lbs.
POWER FS = 2.2 kW (fixed)
SCAN RATE = 10 RPM / SEC

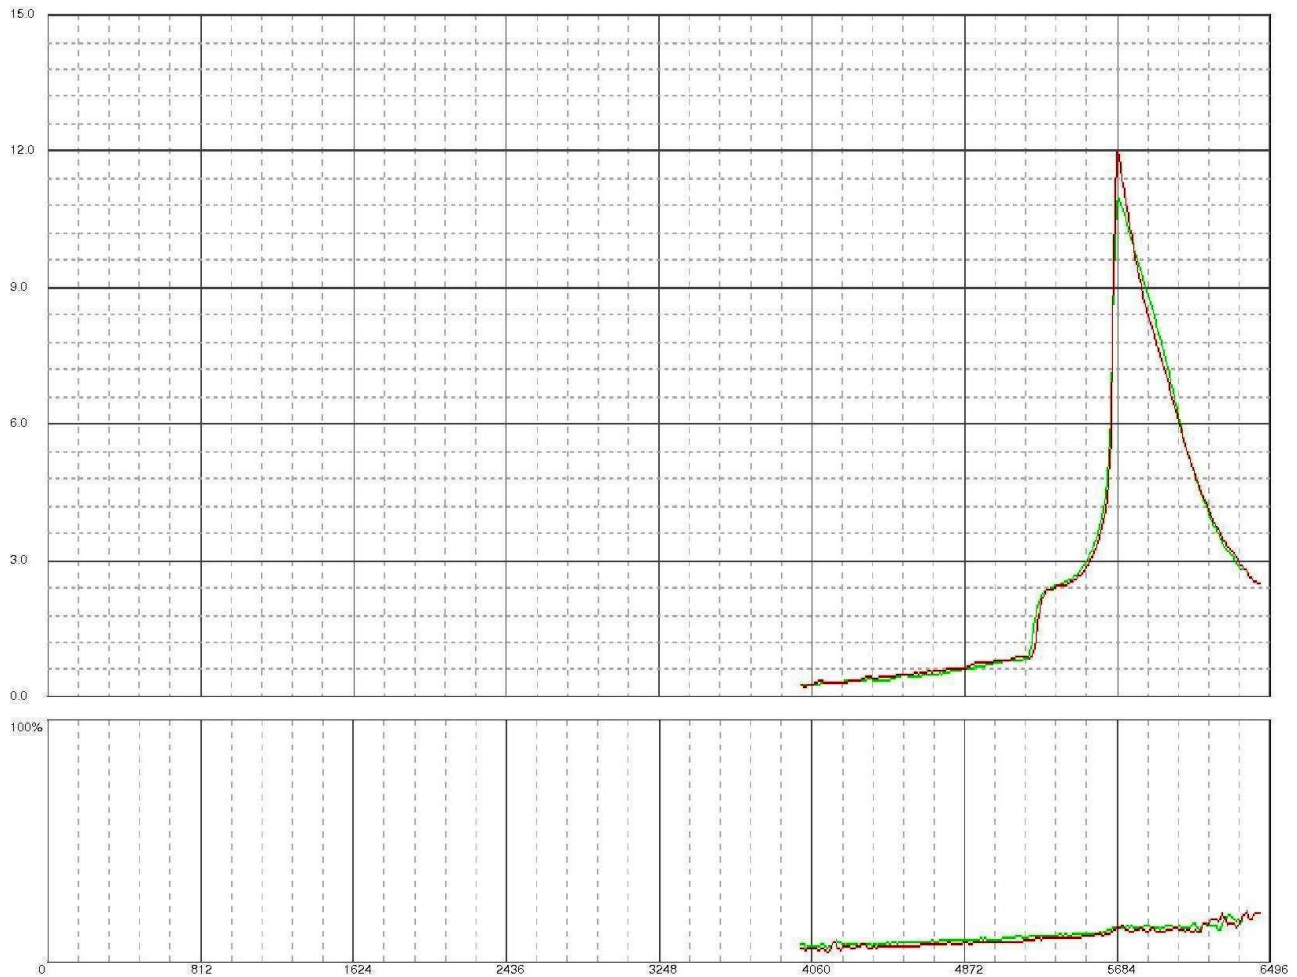
Figure 11: Workpiece 5 treatment using 50% unbalance yielded peak growth, from 10.6 – 12.0 g's, but very little peak shifting. At this unbalance, the low-frequency peaks shown in Fig. 12 were very nominal / un-distinct, so an increase to 100% unbalance was used.

RPM FS = 6500 RPM
ACC FS = 15 g's
UNBALANCE = 2.0 in-lbs.
POWER FS = 2.2 kW (fixed)
SCAN RATE = 10 RPM / SEC

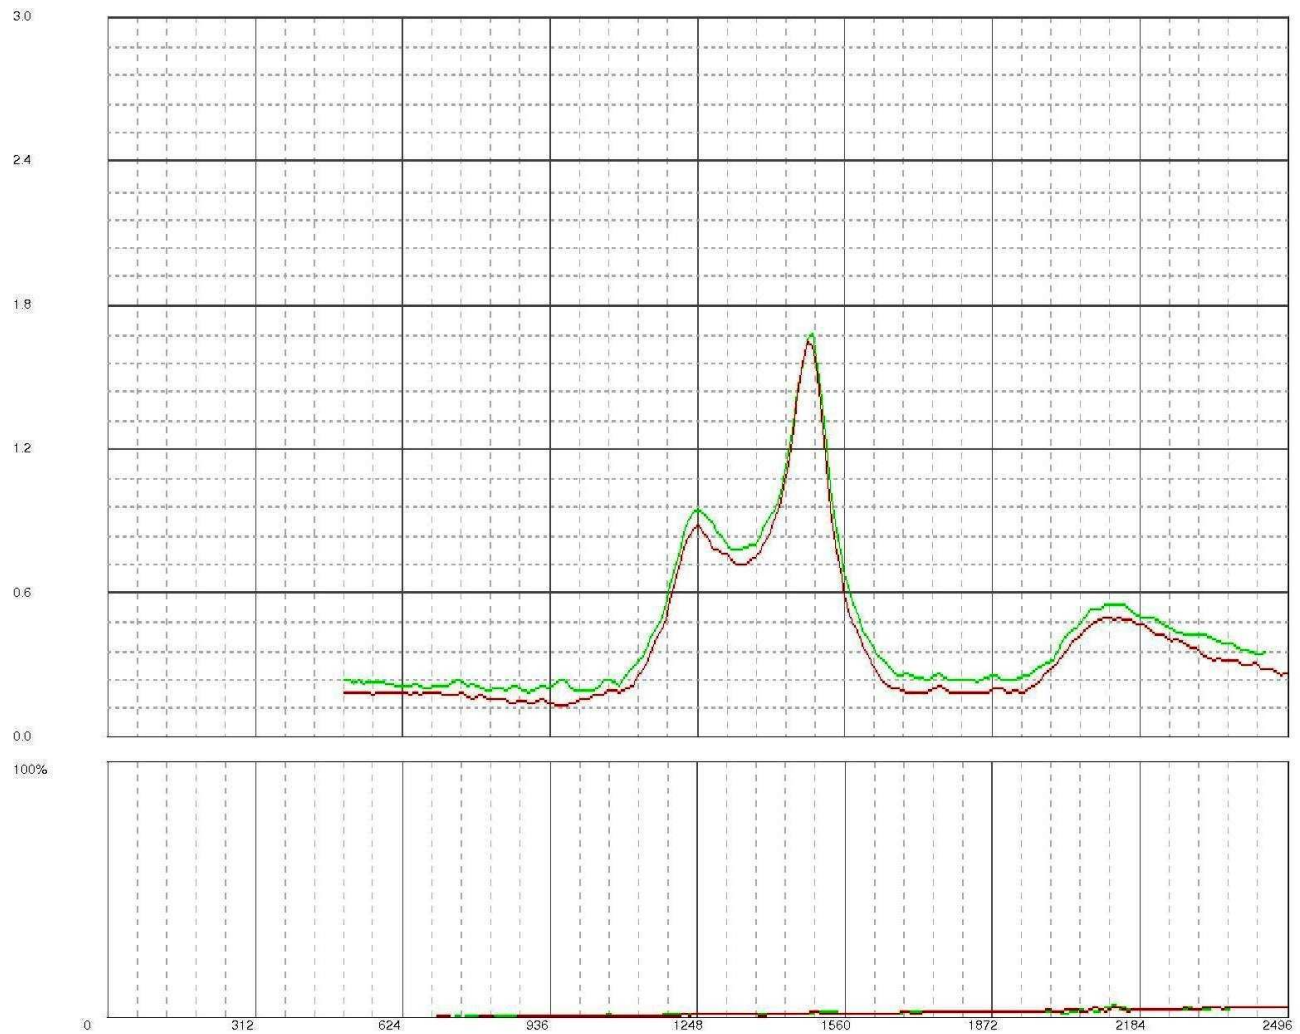
Figure 12: Workpiece 5 treatment using 100% unbalance yielded almost no change, either in the form of peak growth or shifting.

RPM FS = 2500 RPM
ACC FS = 3 g's
UNBALANCE = 4.0 in-lbs.
POWER FS = 2.2 kW (fixed)
SCAN RATE = 10 RPM / SEC

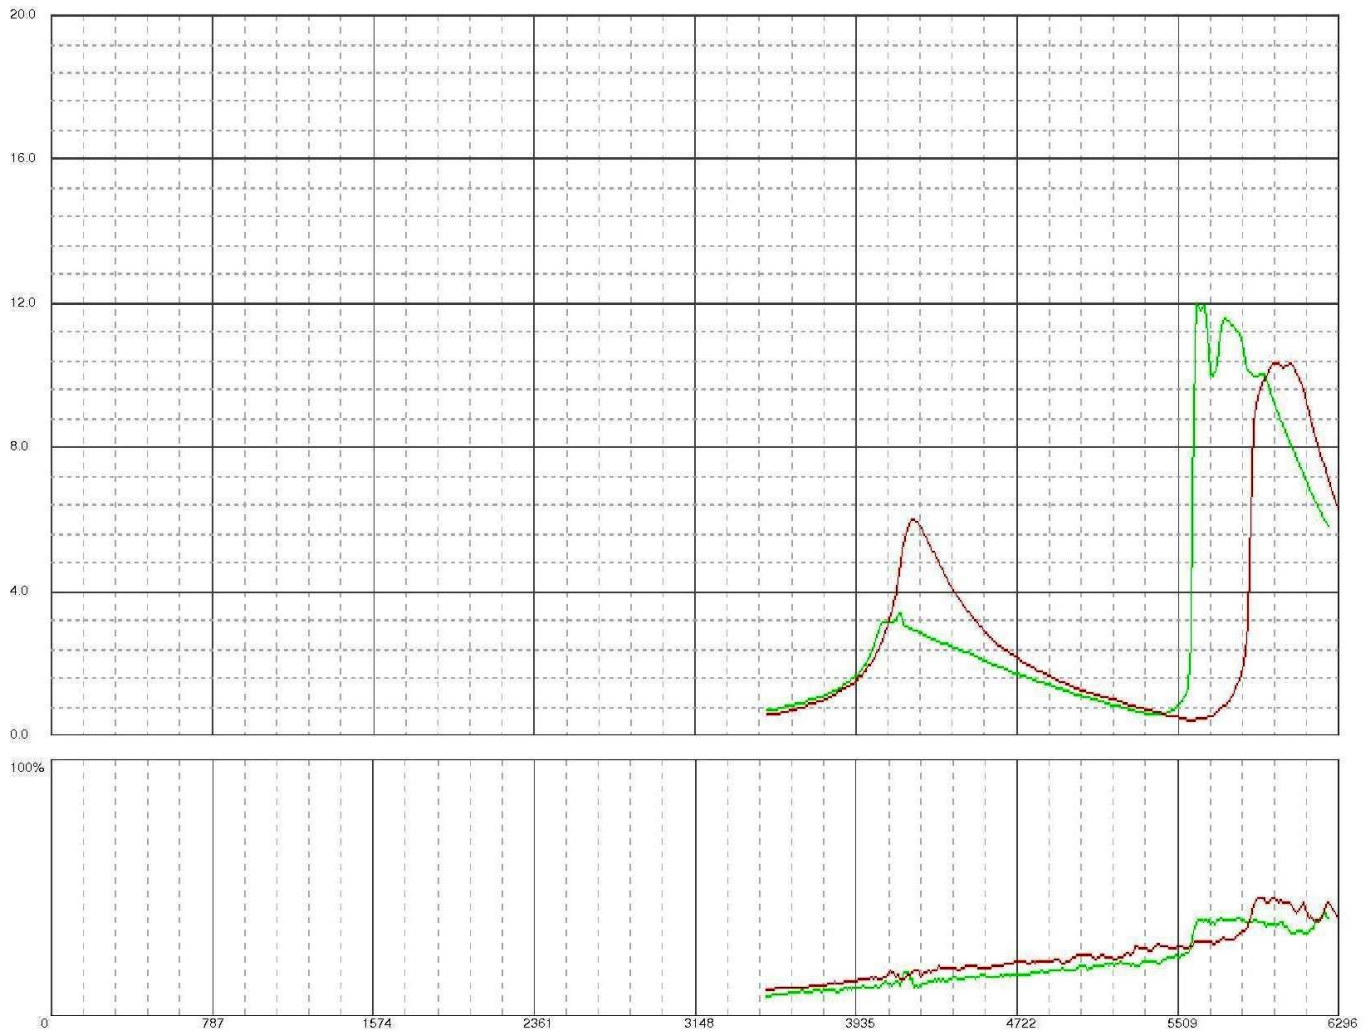
Figure 13: Workpiece 6 treatment using 50% unbalance yielded two peaks, one of which grew and shifted slightly to the right at ~ 4200 RPM, the other reducing slightly and shifting further to the right. These changes are most commonly seen when changes in workpiece shape / dimensions take place. See pages for further discussion.

RPM FS = 6300 RPM
ACC FS = 20 g's
UNBALANCE = 2.0 in-lbs.
POWER FS = 2.2 kW (fixed)
SCAN RATE = 10 RPM / SEC

Although a number of the changes in resonance pattern were classical (peak growth, peak shift to the left) for VSR Treatments, several peaks shifted to the right, shrank, or a combination of both. These later changes experience has shown usually indicate that the workpiece itself has changed shape. Simple structures, with minimal “cross-membering”, i.e., lack of stiffening members in the construction orthogonal to a dominant length, a condition common to long shafts or plate stock, are more prone, due to the nominal stiffness orthogonal to the workpiece length, to distortion machining, stress relieving (whether thermal, vibratory or accidental / unintentional, e.g. during transport).

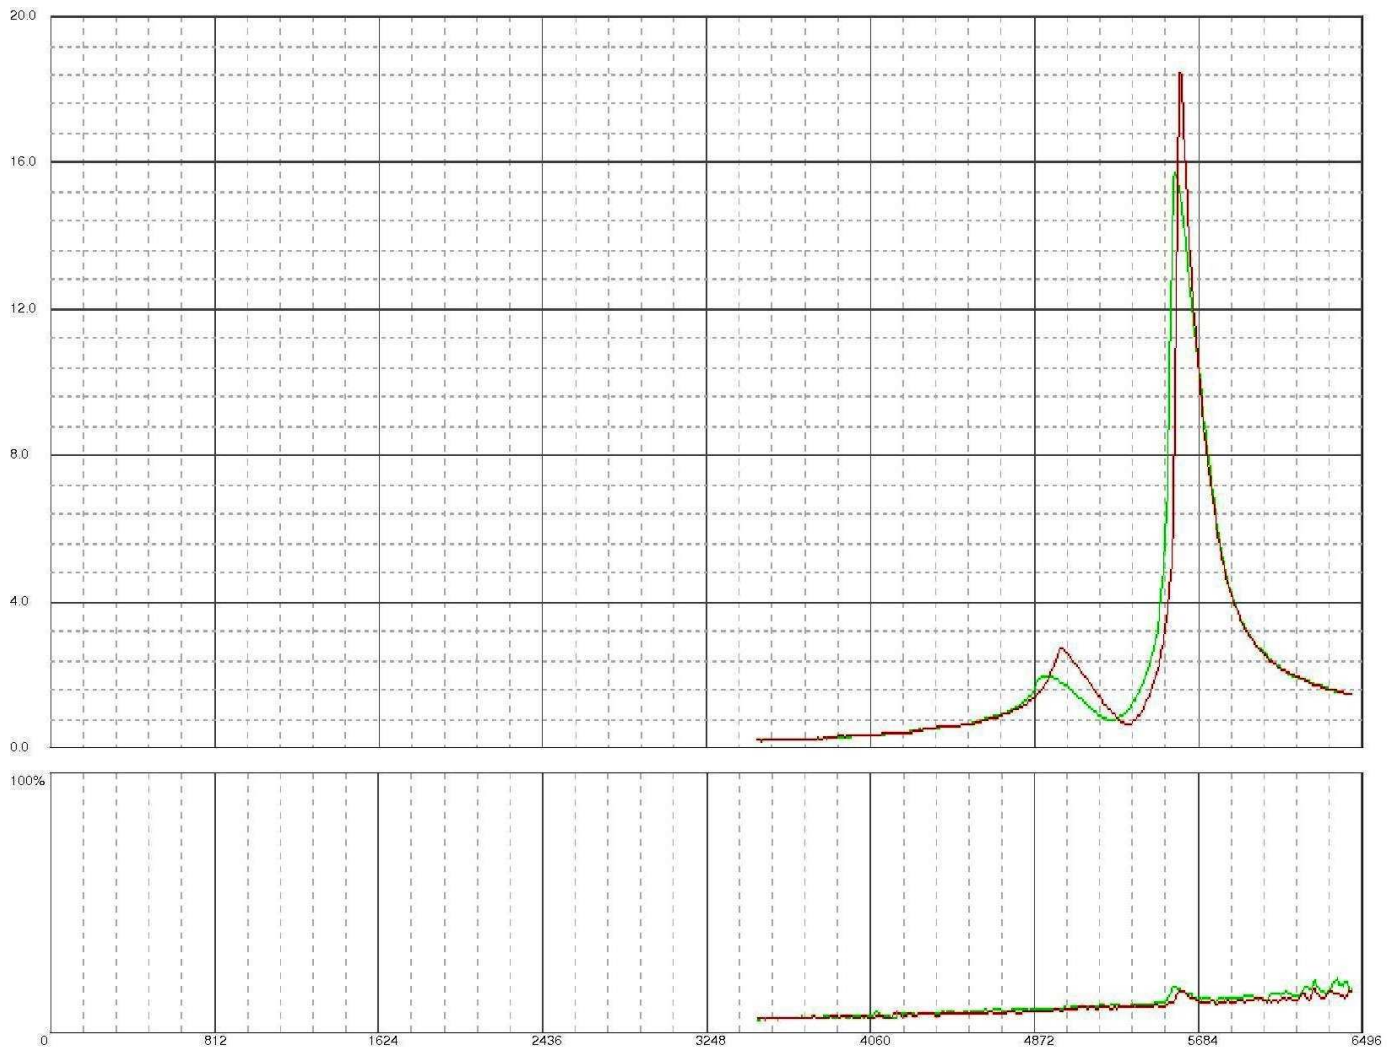
Figure 14: Workpiece 7 treatment using 50% unbalance yielded peak growth, with modest peak shifting to the right. Again, the peak shifting to the right is often accompanied by a change in shape of the workpiece.

RPM FS = 6500 RPM
ACC FS = 20 g's
UNBALANCE = 2.0 in-lbs.
POWER FS = 2.2 kW (fixed)
SCAN RATE = 10 RPM / SEC
