VSR REPORT

MAG – IAS Hebron, KY Stress Relief Stabilization of 2 meter and 3 meter plates

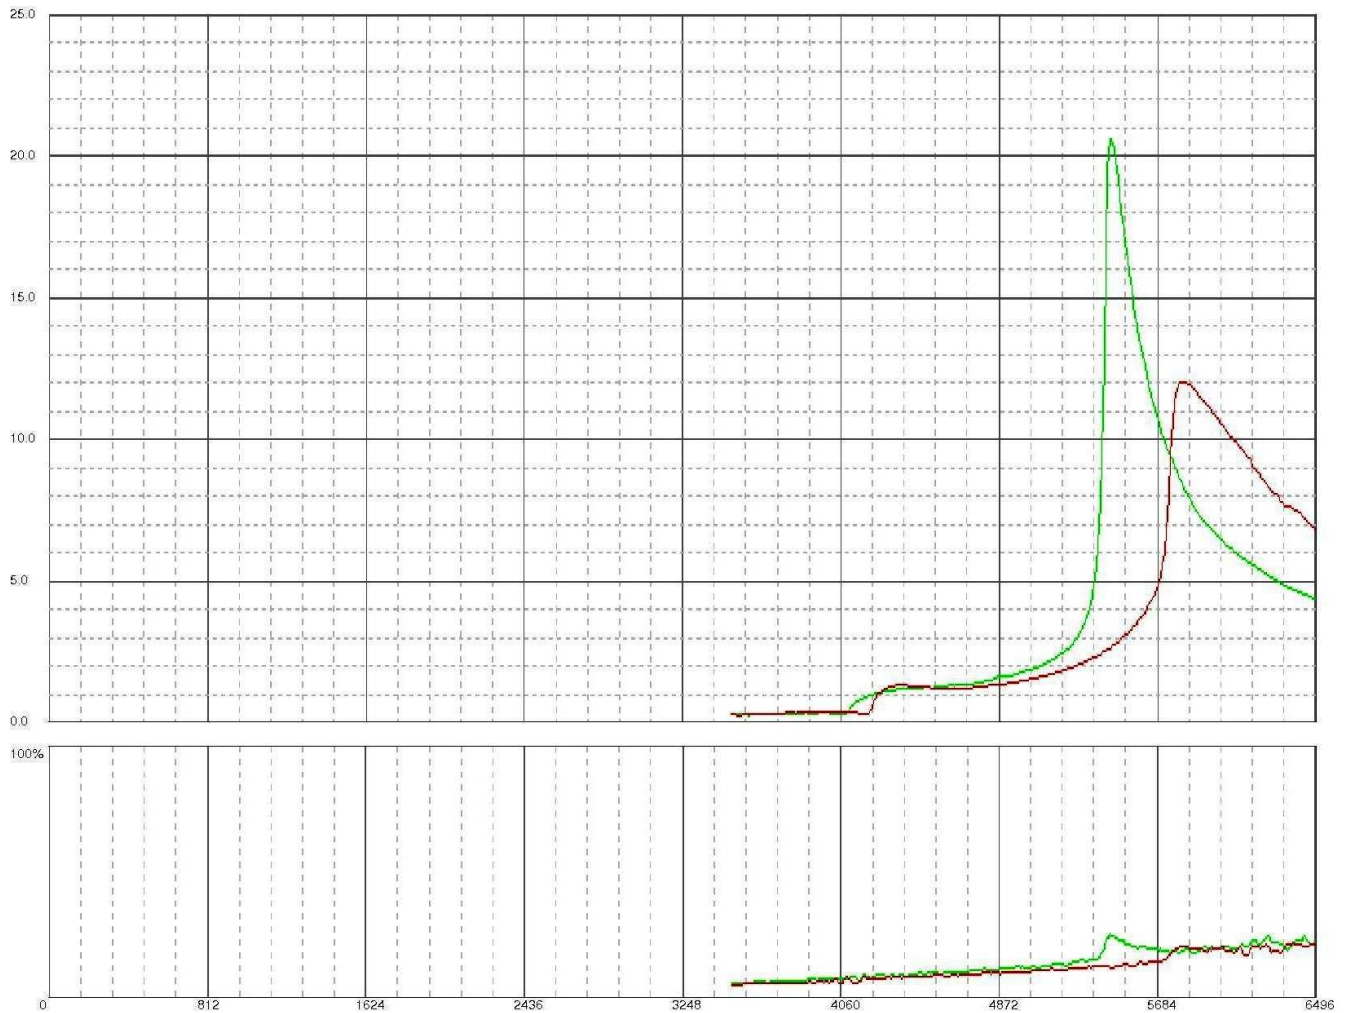
Figure 15: Workpiece 8 treatment using 50% unbalance yielded a single peak, which reduced and shifted to the right. This type of response is most commonly seen when a change in workpiece shape occurs.

RPM FS = 6500 RPM
ACC FS = 25 g's
UNBALANCE = 2.0 in-lbs.
POWER FS = 2.2 kW (fixed)
SCAN RATE = 10 RPM / SEC
