VSR Report

Three D Metal Works

Clam Shell Fabrication Project

Advanced VSR Technology

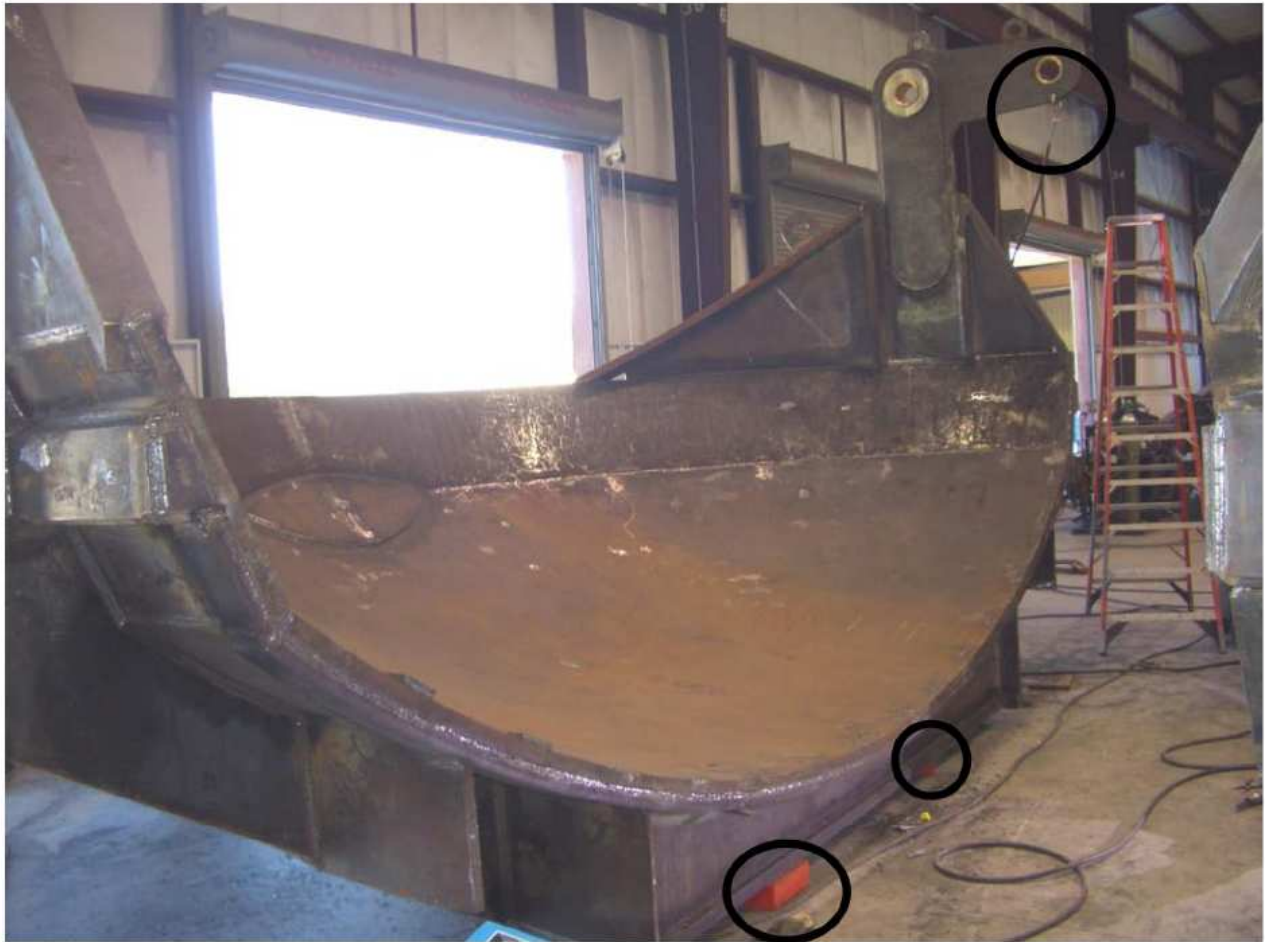
Figure 1: 24.5 ton Clamshell Bucket half setup for VSR Treatment. Note location of two Load Cushions (circled); the other two Cushions were placed on the opposite side (one being visible in Figure 2). The Accelerometer is visible on right lifting arm (circled), near the top of the photo. This particular Accelerometer location was used during a second Treatment of this workpiece, which turned out to be unnecessary (first VSR Treatment was fully effective), as indicated by the VSR Treatment Charts shown in Figures 3 – 6.

The first workpiece was placed on four Isolation Load Cushions. These Cushions were placed in such a manner as to minimize damping of the workpiece, which maximizes resonant response, *see* Figures 1 and 2. Resonant frequency vibration is used because of its ability to maximize the flexure of the workpiece, which is key to the effectiveness of vibratory stress relief. Several independent research works, including those of Hahn¹, Shankar², and Yang, Jung and Yancey³, have proven that resonance frequency vibration is the most effective form of vibration to relieve stress.

The Accelerometer was initially placed in the location shown in Figure 2. Later, after the first VSR Treatment, the Accelerometer was moved to the location shown in Figure 1. Although this Accelerometer location did pick-up some additional resonance peaks, shown in Figures 5 and 6, Vibration dwell on these peaks did not cause them to grow or shift which proved it did not stress relieve the workpiece any more than the peaks displayed in Figure 3 and 4.

On the first Clamshell a second Treatment was performed with a new setup which relocated the Accelerometer to the top of the Clamshell's lifting arm. The results of the second Treatment indicated this additional Treatment was not necessary (no audible tones or additional peaks occurred, *see* Figure 5, and so only one Treatment was deemed necessary on the second Clamshell, *see* Figure 7.

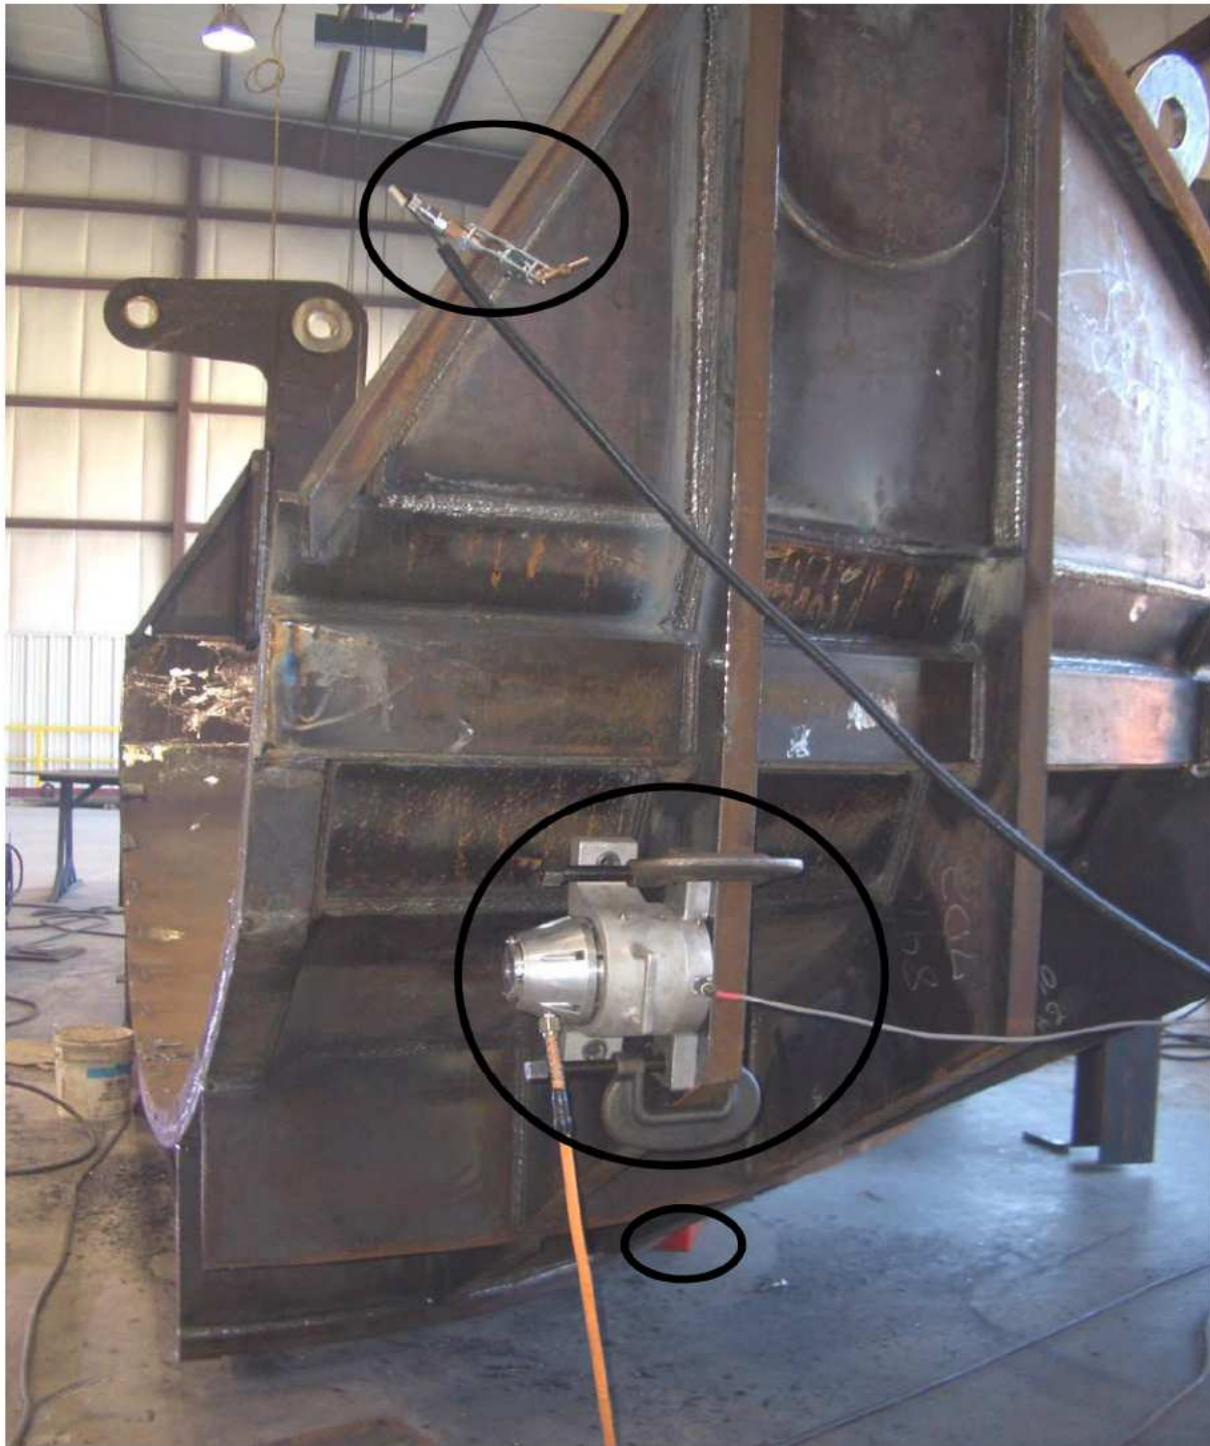
Figure 2: Another view of Clamshell setup for VSR Treatment. One of two Load Cushions supporting the rear of the Clamshell is visible (circled), below the Vibrator (circled). Note that the support leg on the right is purposely not touching the floor; the full weight of the workpiece rested on the 4 Load Cushions.

The Vibrator was clamped to a vertical plate on the side of the workpiece, *see* Figure 2.

The Vibrator oriented with its Axis of Rotation Horizontal (AOR-H), as shown in Figure 2, was found to produce the best resonances.
